Assurance Home Inspectors

Residential Property Inspection Report

1234 Sample St
Rockford, IL 61108

Inspection Date: 07/15/24

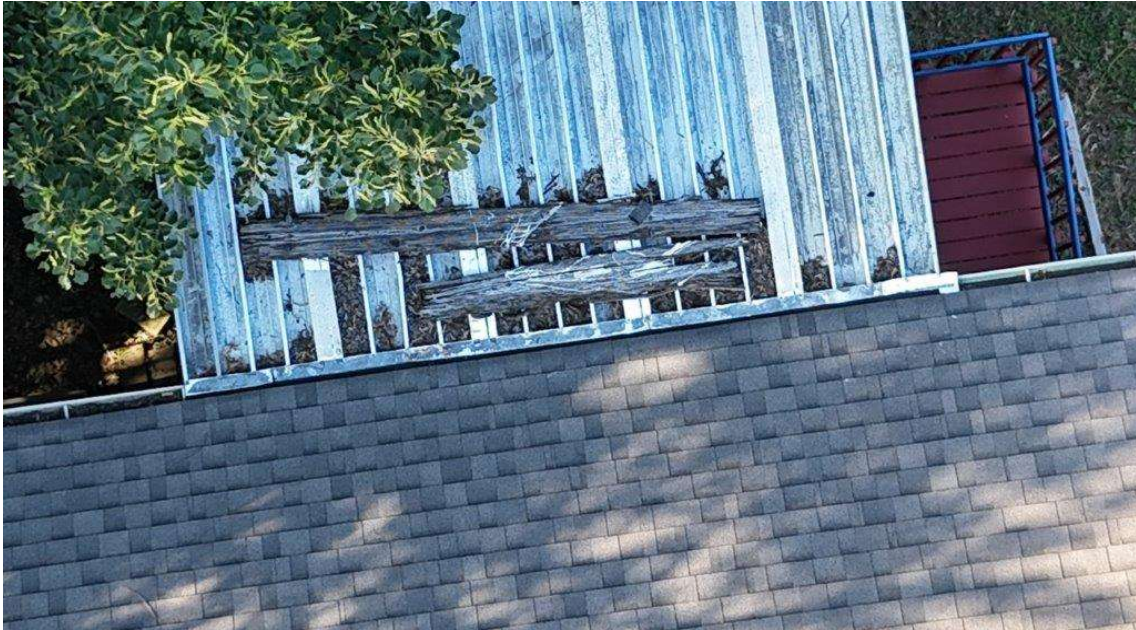
Tree debris on roof

Debris are accumulated on the northeast porch's roof. This could lead to poor drainage and damage. Recommend this be cleaned by a qualified person.

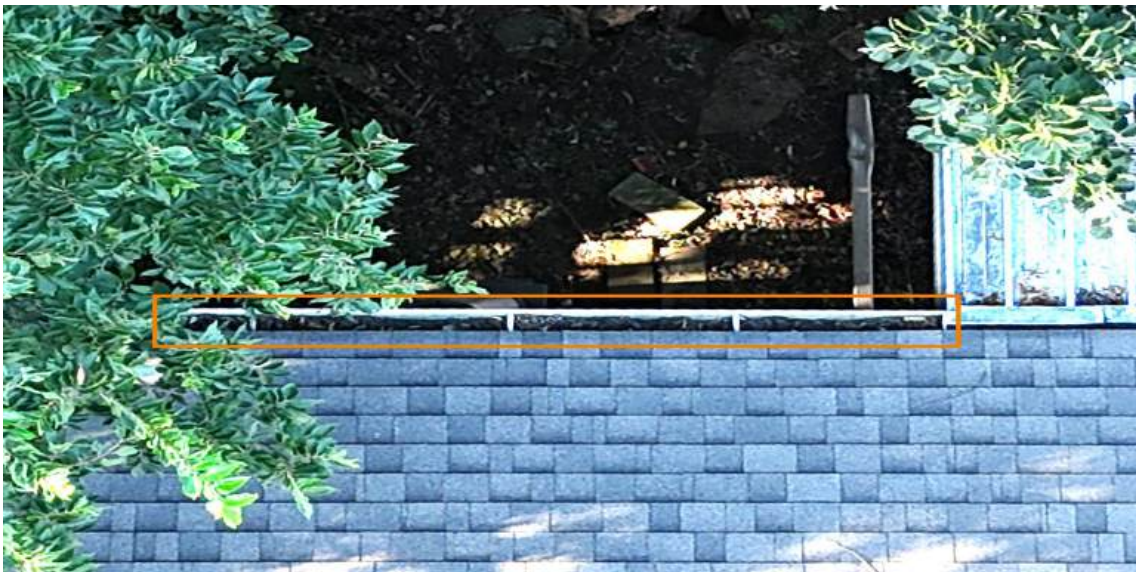
Debris on gutters

Debris are accumulated on the northeast gutters. Recommend cleaning twice a year or install gutter guards.

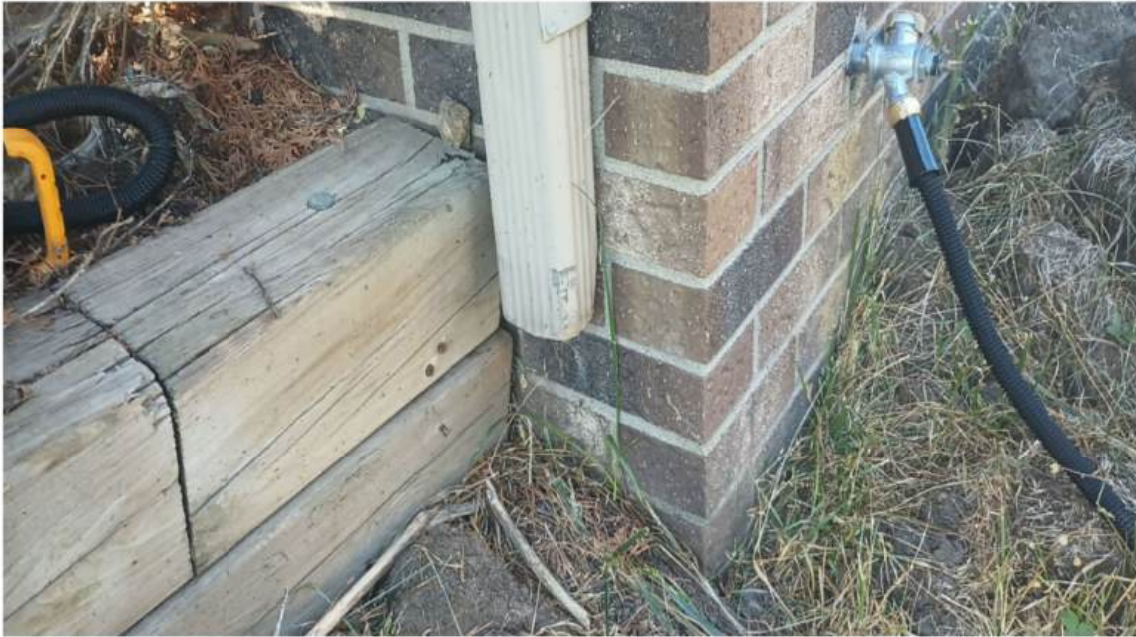
Downspout extension missing**ROOFING**

Downspout drain extension is missing on the southeast corner. This could result in excessive moisture in the soil, which can lead to water entry and foundation/structural movement. Recommend adding downspout extensions that drain at least 6 feet from the foundation.

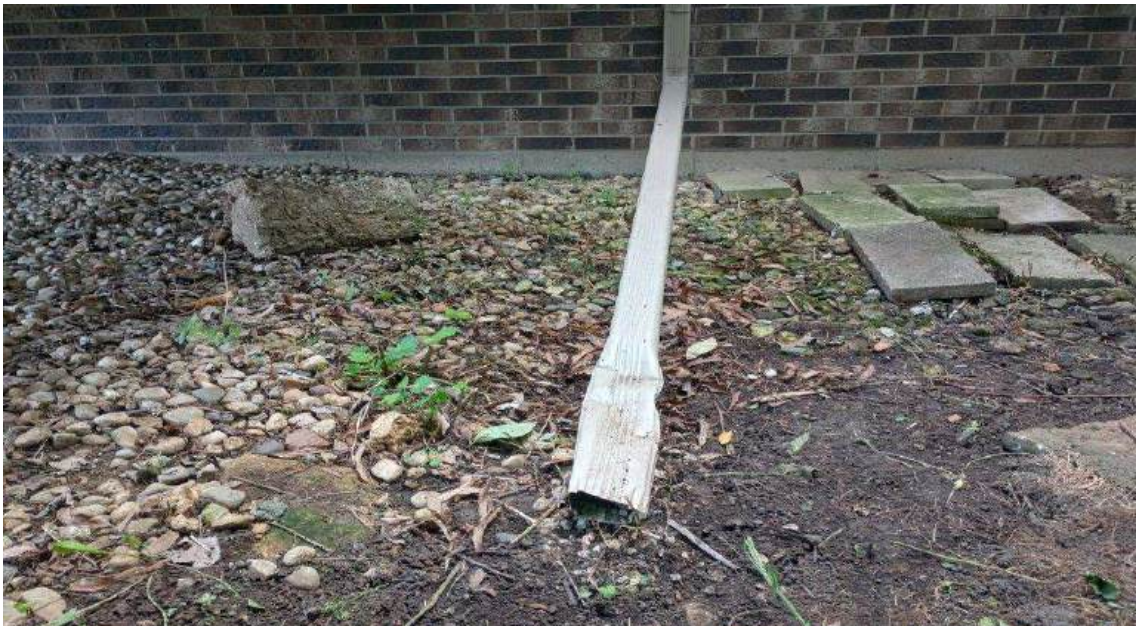
**Damaged downspout extension****ROOFING**

Gutter downspout extension is crushed. Recommend replacing downspout section.

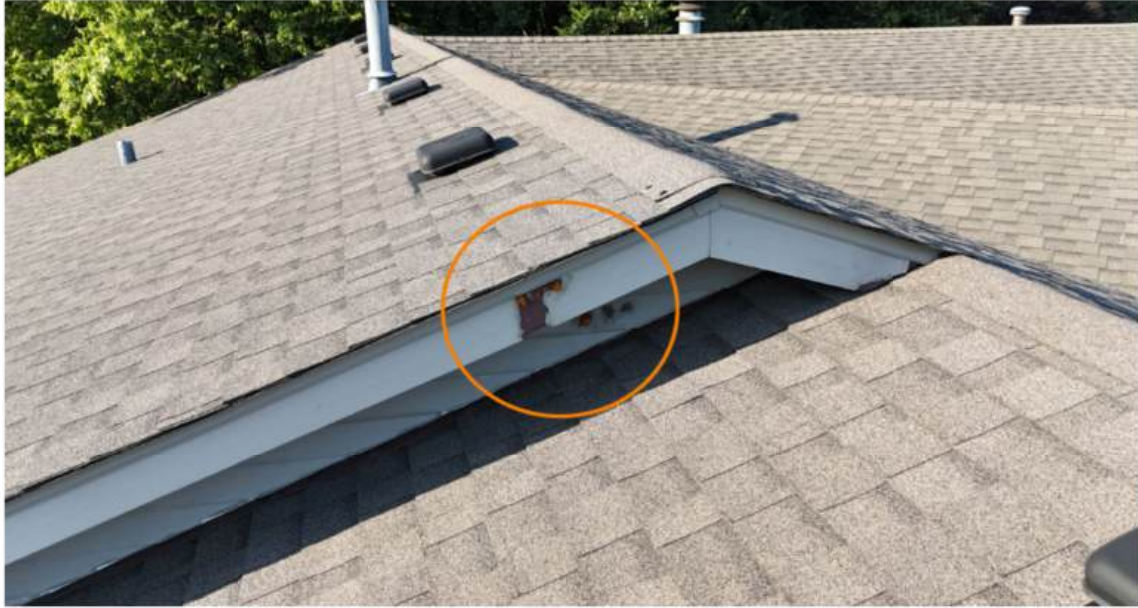
Damaged fascia

Section of fascia on the roof is broken following the apparent removal of a satellite dish. Three cable entry holes can also be seen on the siding below the fascia. Recommend evaluation/repair by a qualified siding professional.

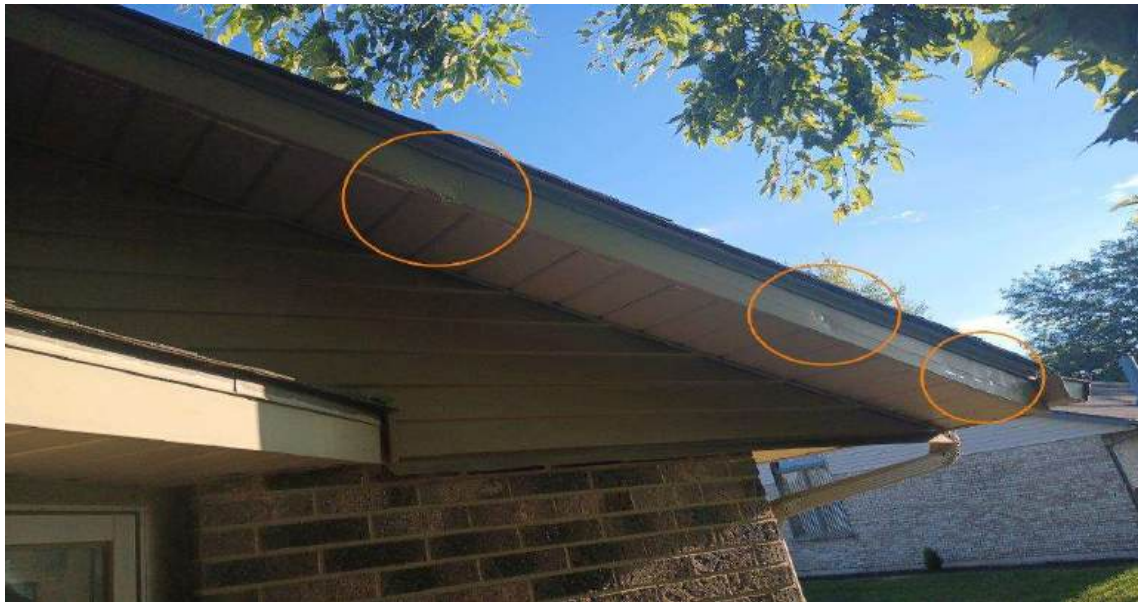
Damaged fascia

This section of the fascia on the northwest corner seems to have been repaired. Recommend checking with owner or further evaluation by a qualified siding professional.

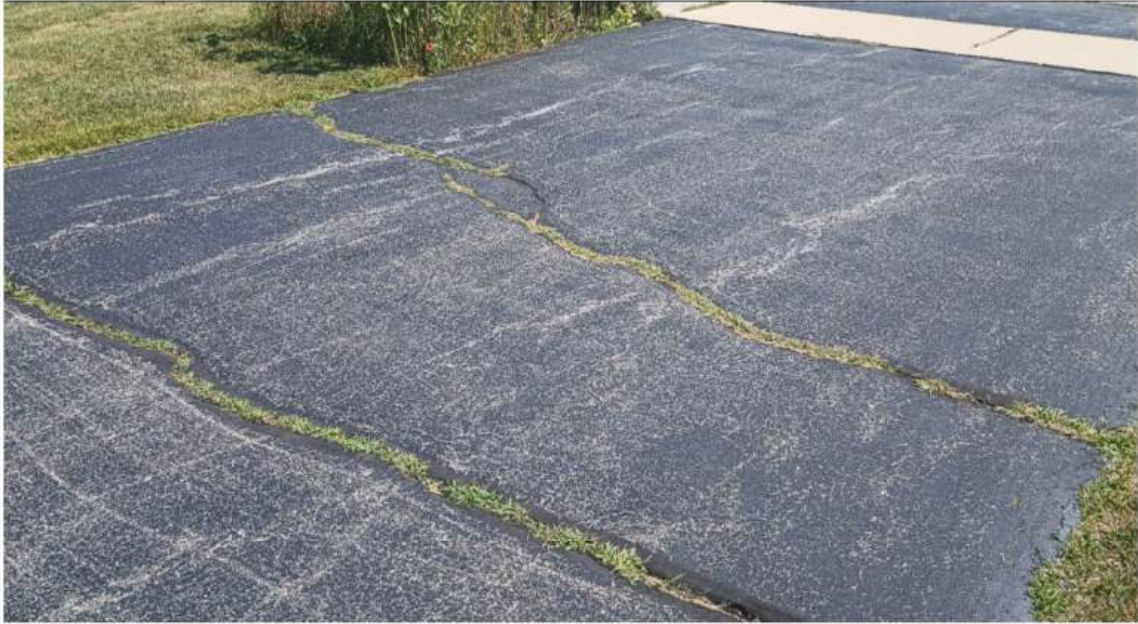
Driveway cracking

Recommend caulking and sealcoating by a qualified professional.

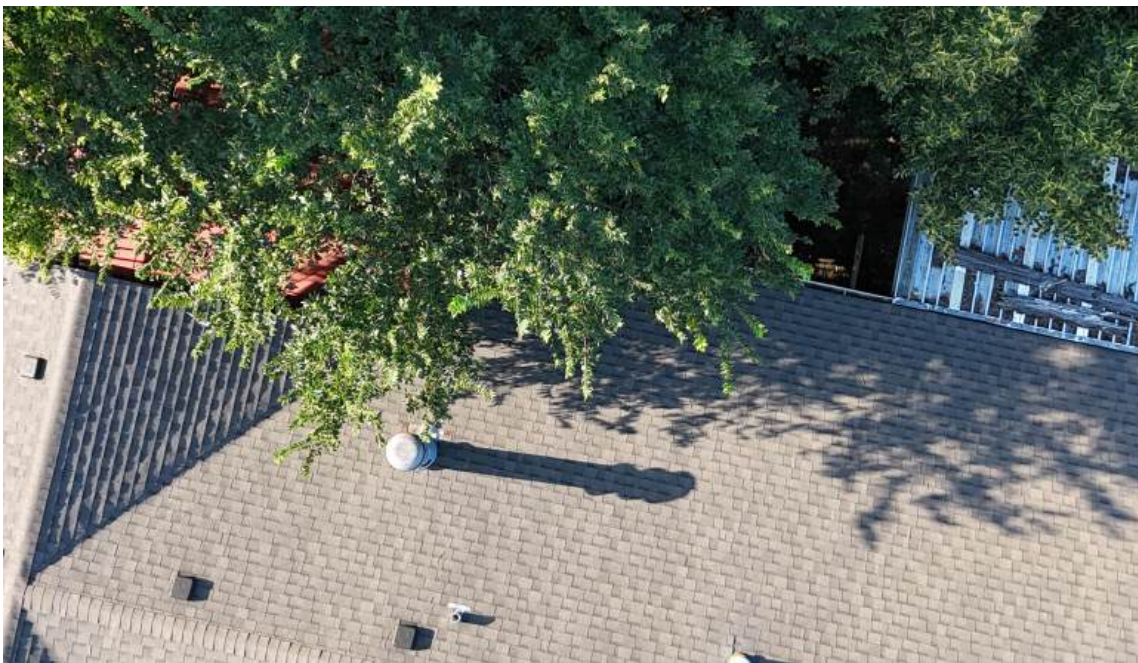
Tree overhanging the roof

Trees observed overhanging the roof. This can cause damage to the roof and prevent proper drainage. Recommend a qualified tree service trim the overhanging branches.

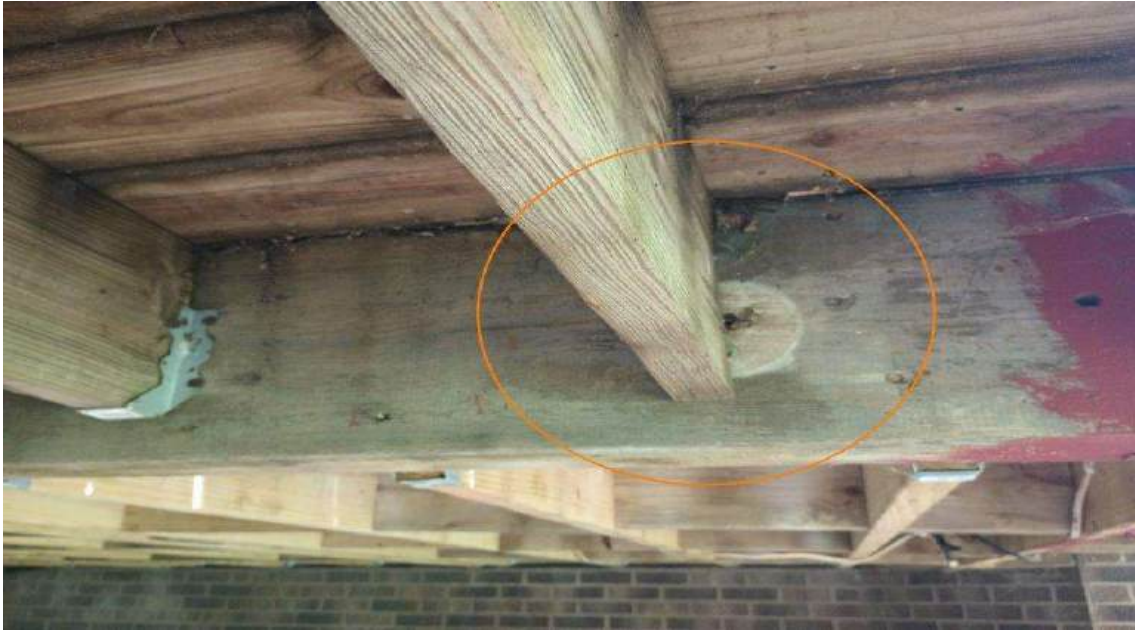
Deck – Missing joist hanger**EXTERIOR**

A joist hanger is missing under the main deck. The joist is nailed, however it is recommended a qualified carpenter to install a joist hanger to prevent potential movement.

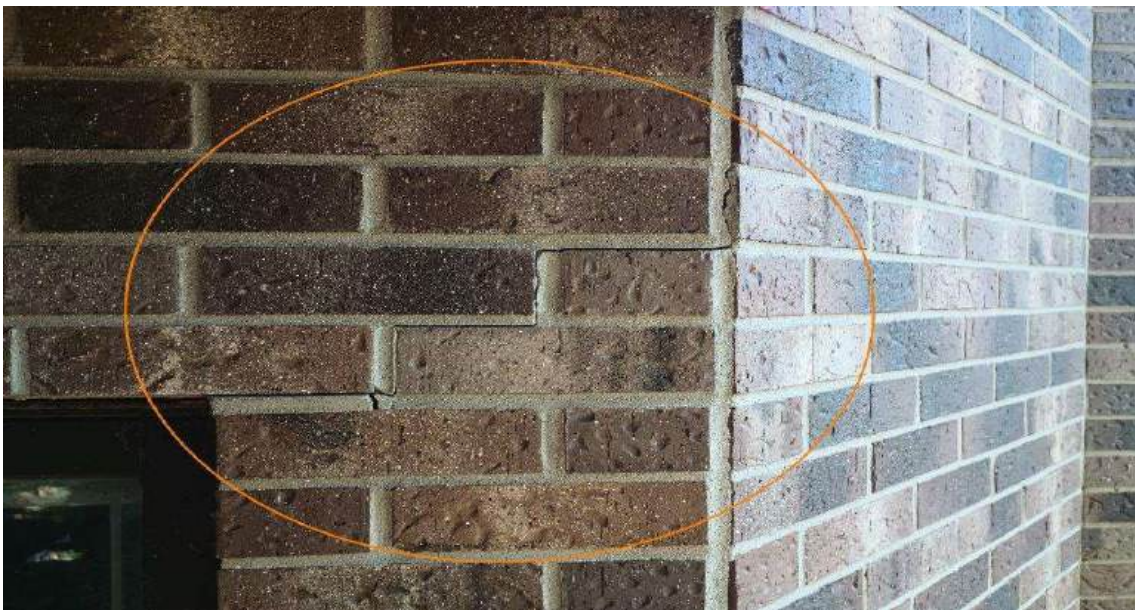
**Stair-step cracking on brick veneer siding****EXTERIOR**

Observed on the upper corner of the northwest basement window. These are generally not an issue. Recommend monitoring and further evaluation by a qualified siding professional.

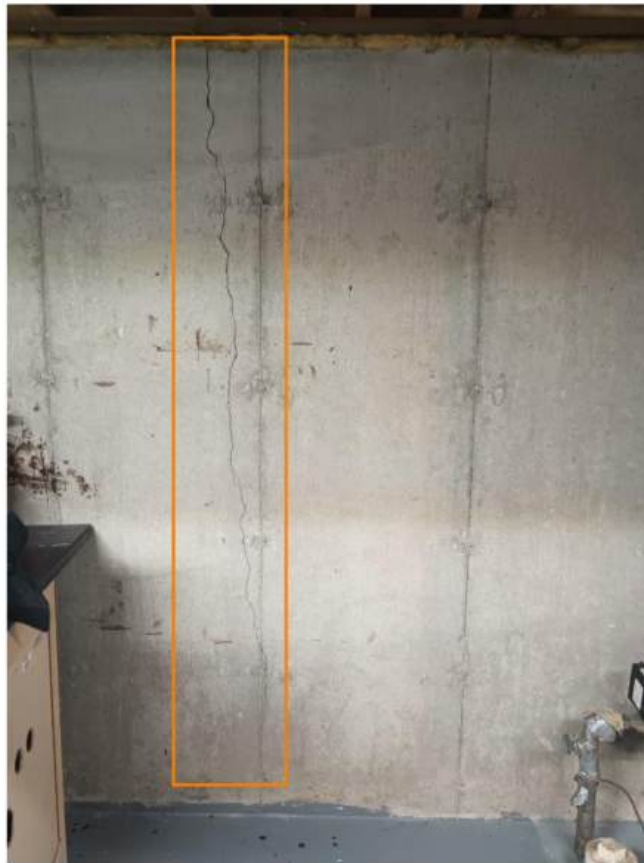
Minor vertical foundation crack

This is common as concrete ages and shrinkage surface cracks are normal. Recommend monitoring and further evaluation by qualified contractor if cracking increases.

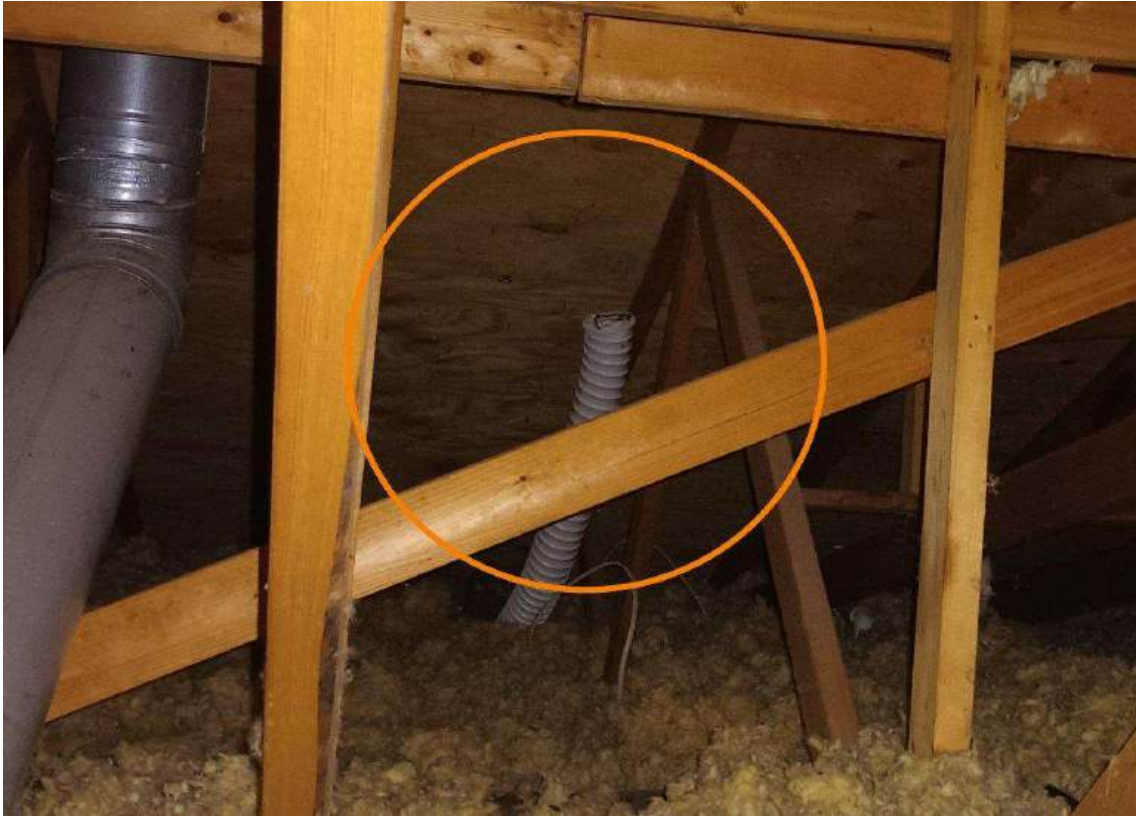
Bathroom extractor fan vents into the attic

Master bedroom bathroom fan vents into attic, can cause moisture and mold. Recommend a qualified professional properly install exhaust fan vent that terminates to the exterior.

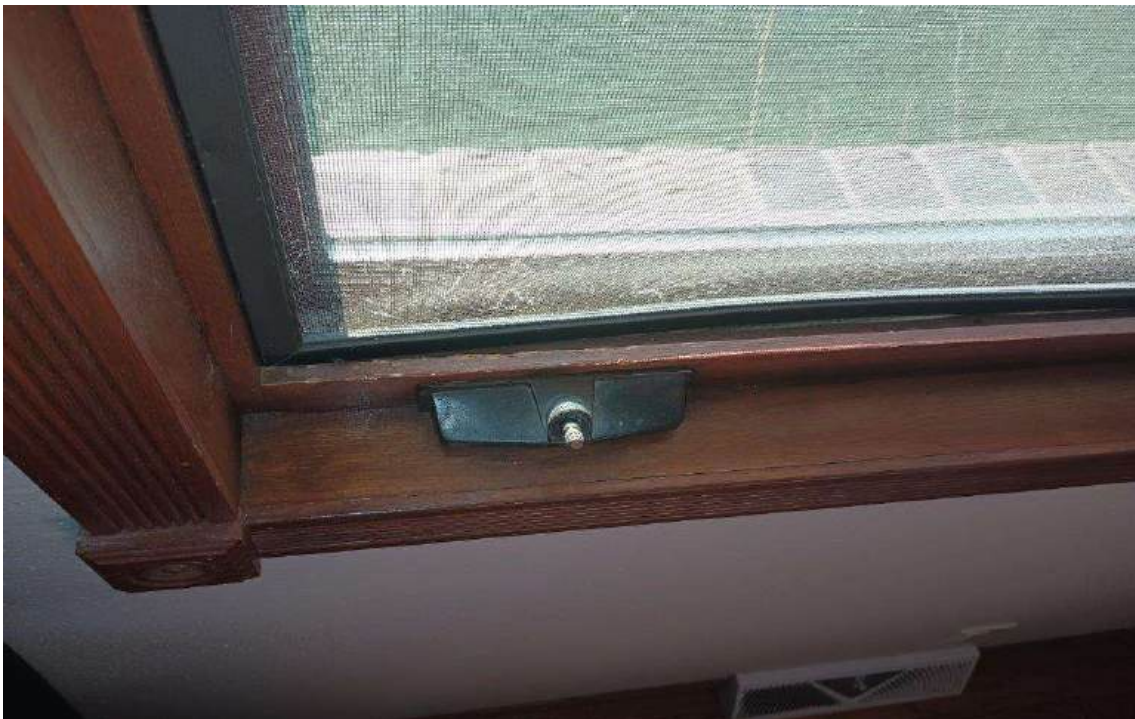
🔍 Casement window operator handle is missing

The handle is missing on the main room window and the window cannot be opened. Window was not confirmed to work as it could not be fully inspected. Recommend installing handle, this can be found at hardware stores or online.

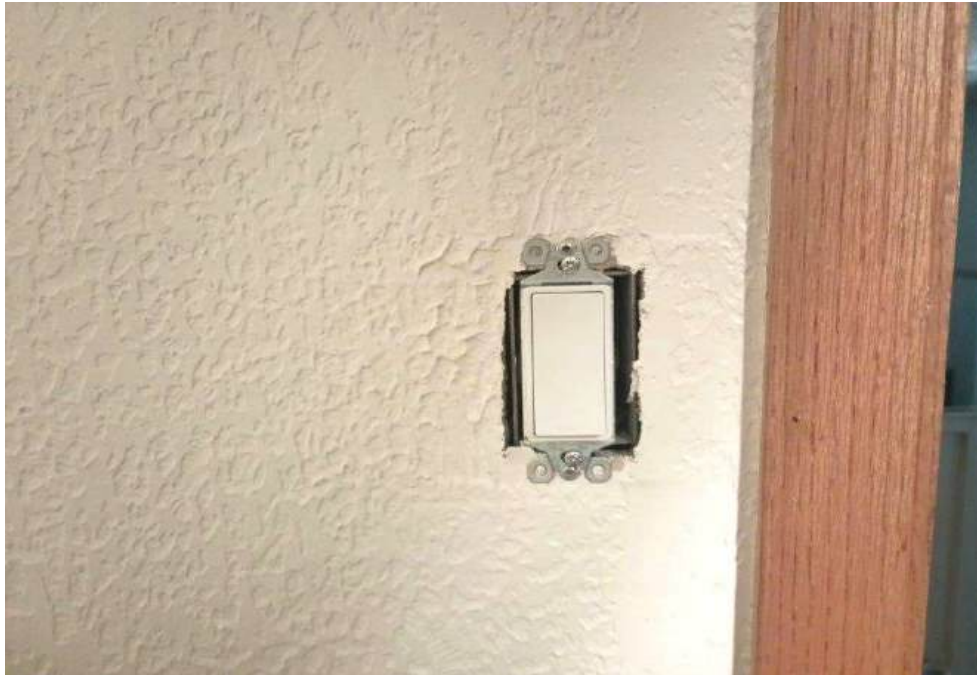
🔍 Outlet cover is missing on main room bathroom**ELECTRICAL**

This is an electrical shock hazard. Recommend a qualified person install a switch plate cover.

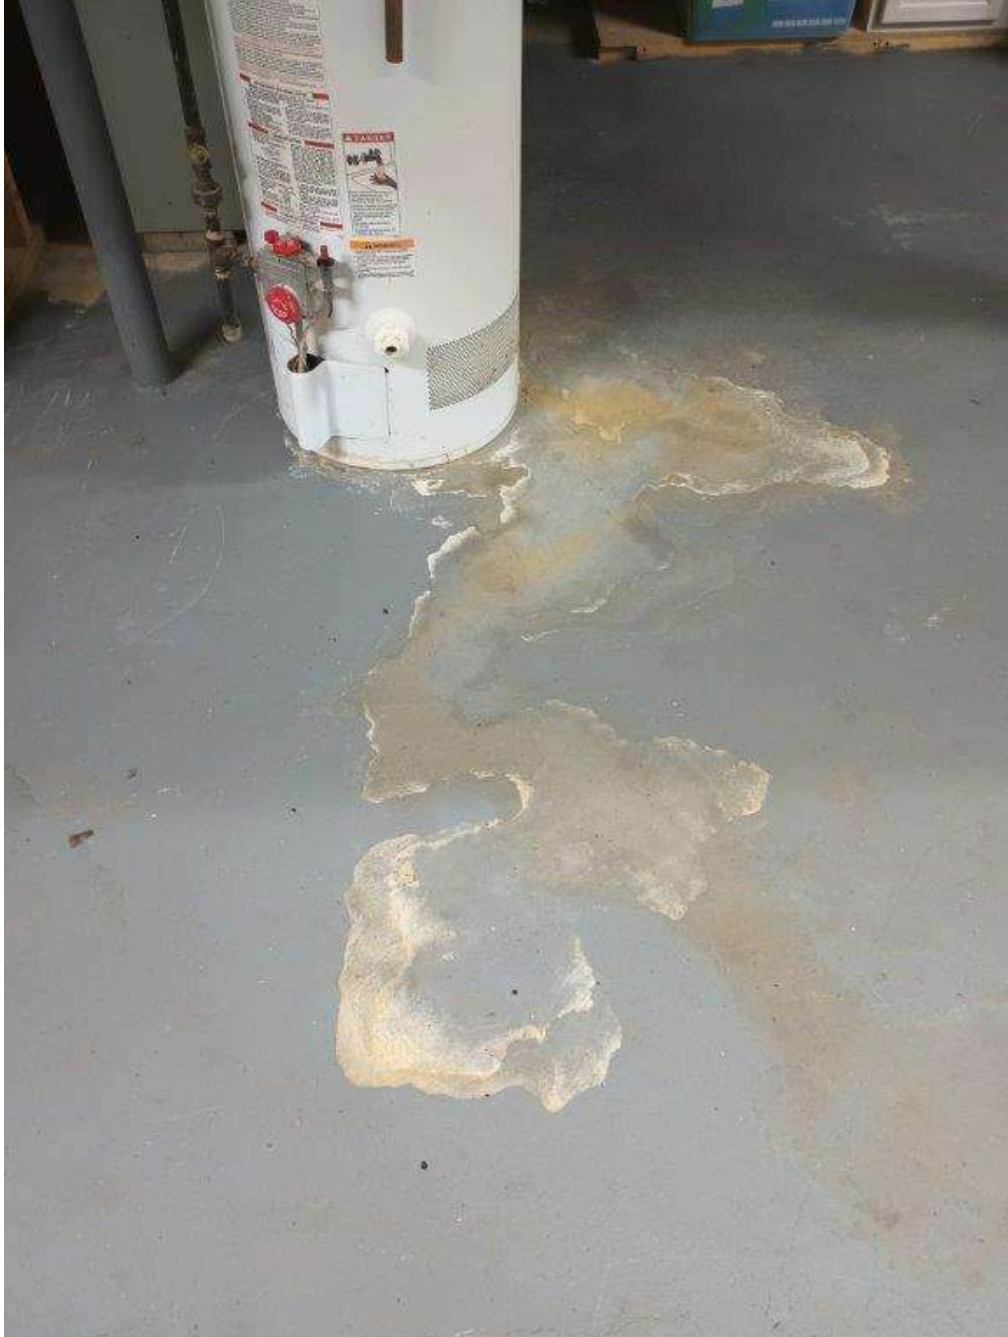
🔑 Water heater is leaking. Recommend replacement by qualified plumber. Details below.

Leaking water heater

Evidence of recent water heater leakage. This water heater is 21 years old and past its normal life expectancy. Recommend replacement by a qualified plumber.

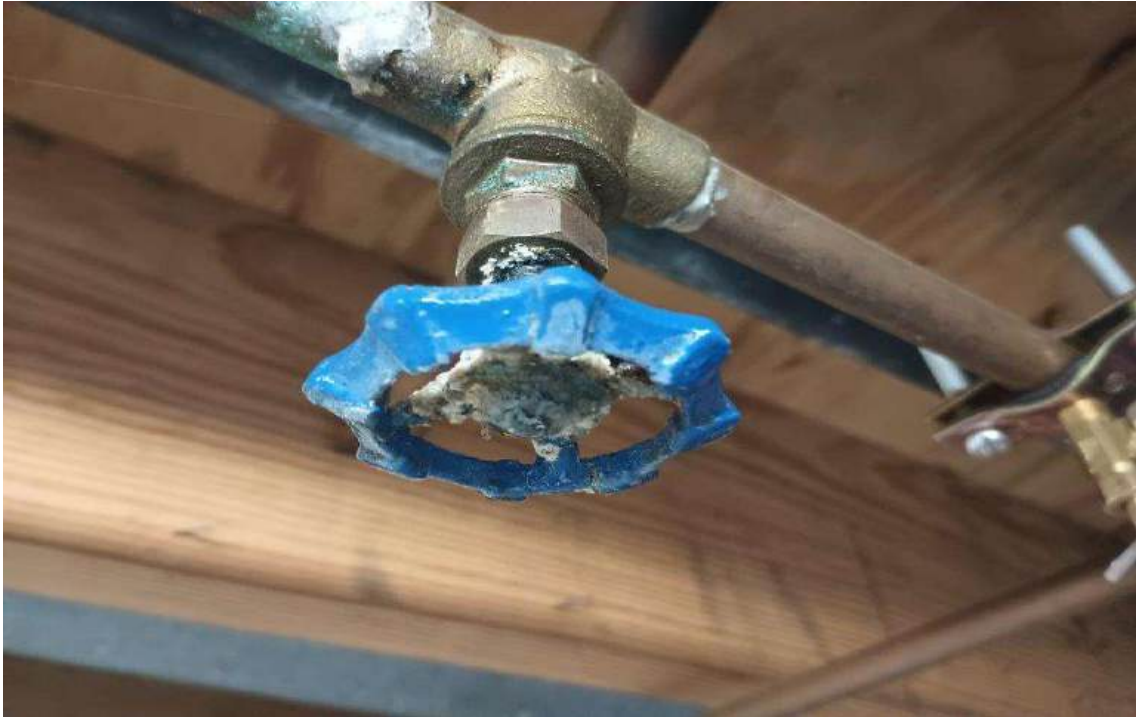
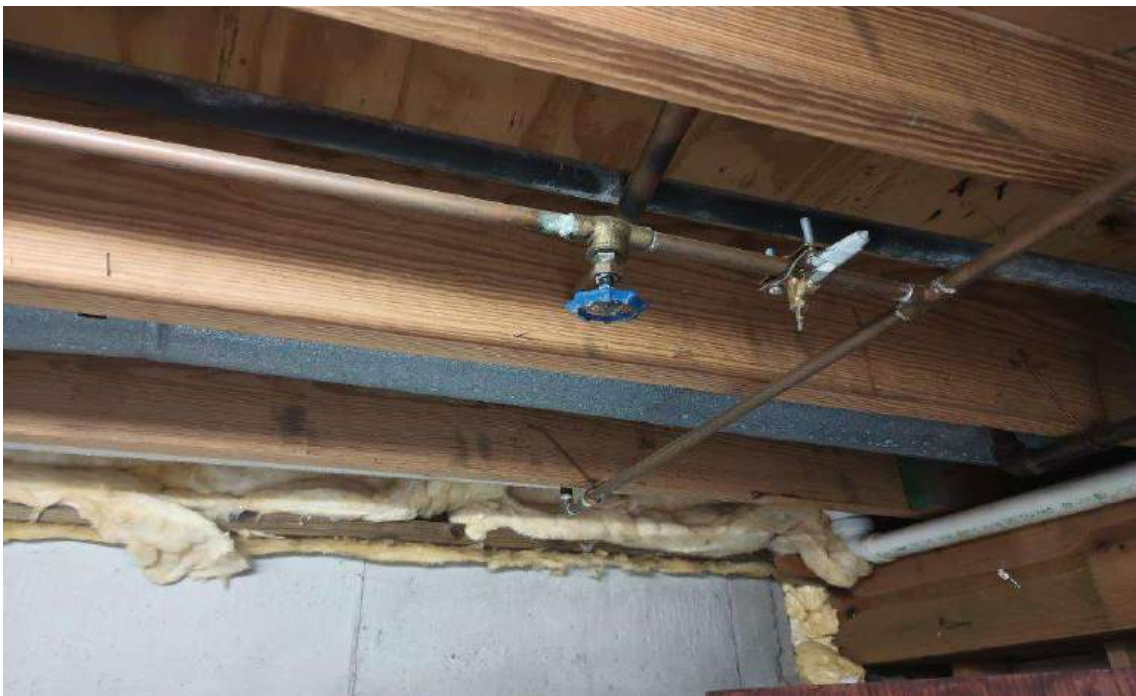
Leaking water valve

Leaky valve located in the basement, near the door to the laundry area. Recommend replacement by a qualified plumber.
